Building observation

State Energy Assessment Workshop

DTE Energy Partnership & Services

Williams Building

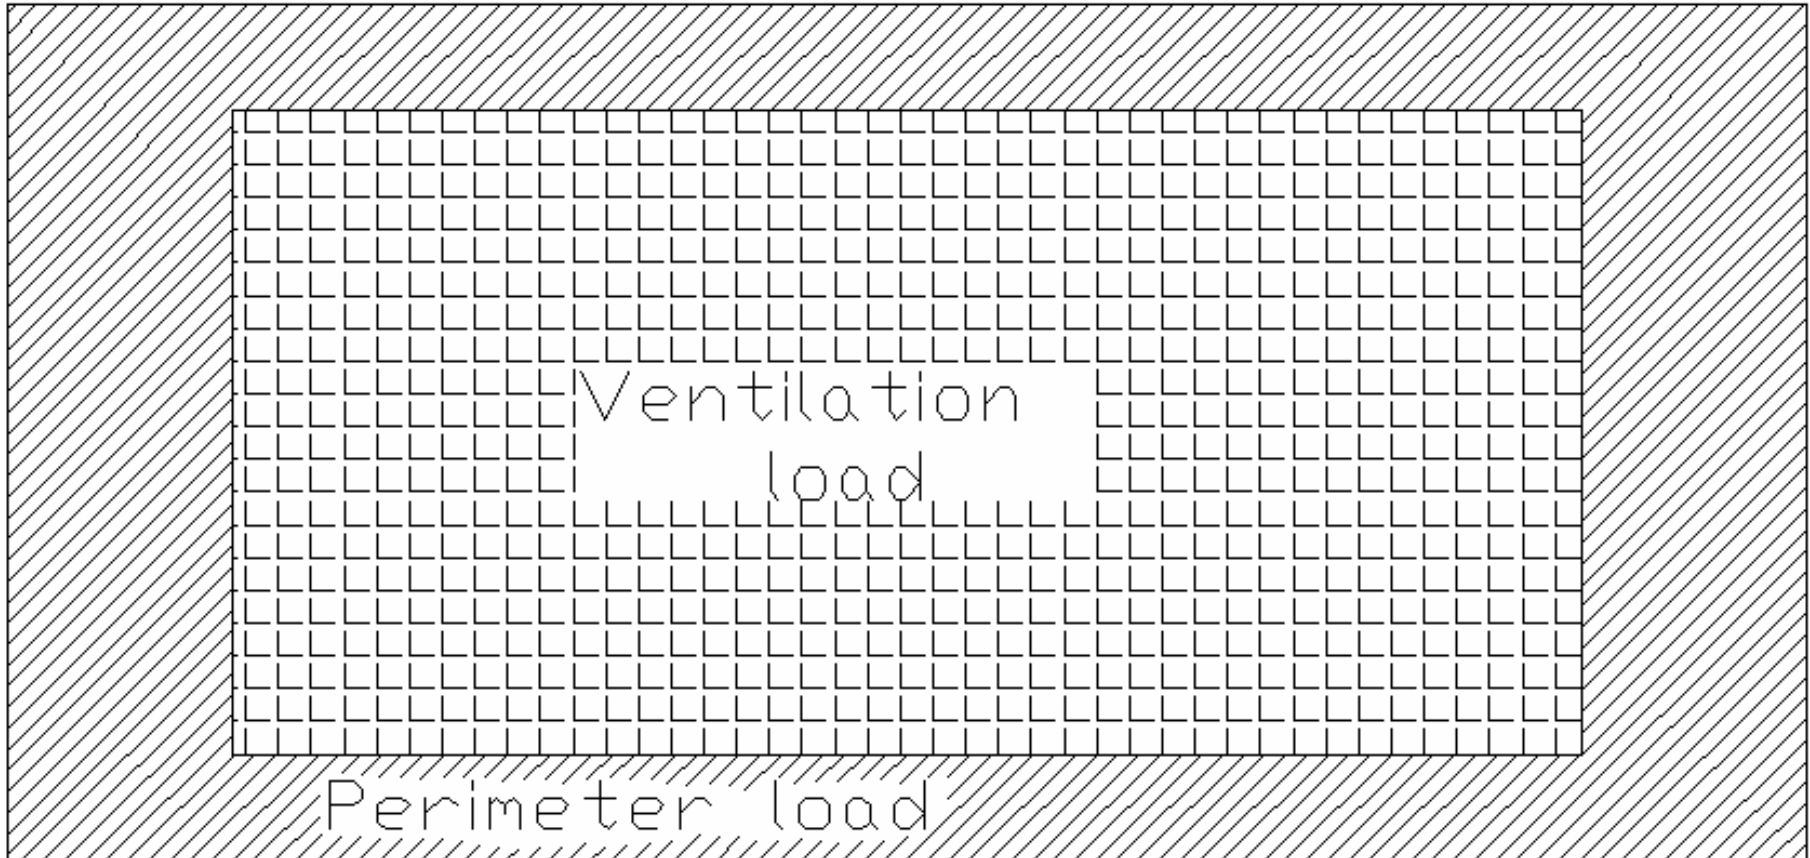
AHU/perimeter radiation

Condensate return is dumped into sewerage

Recommendations -
Cascade heat recovery:

- ☐ Heating system
- ☐ Domestic hot water

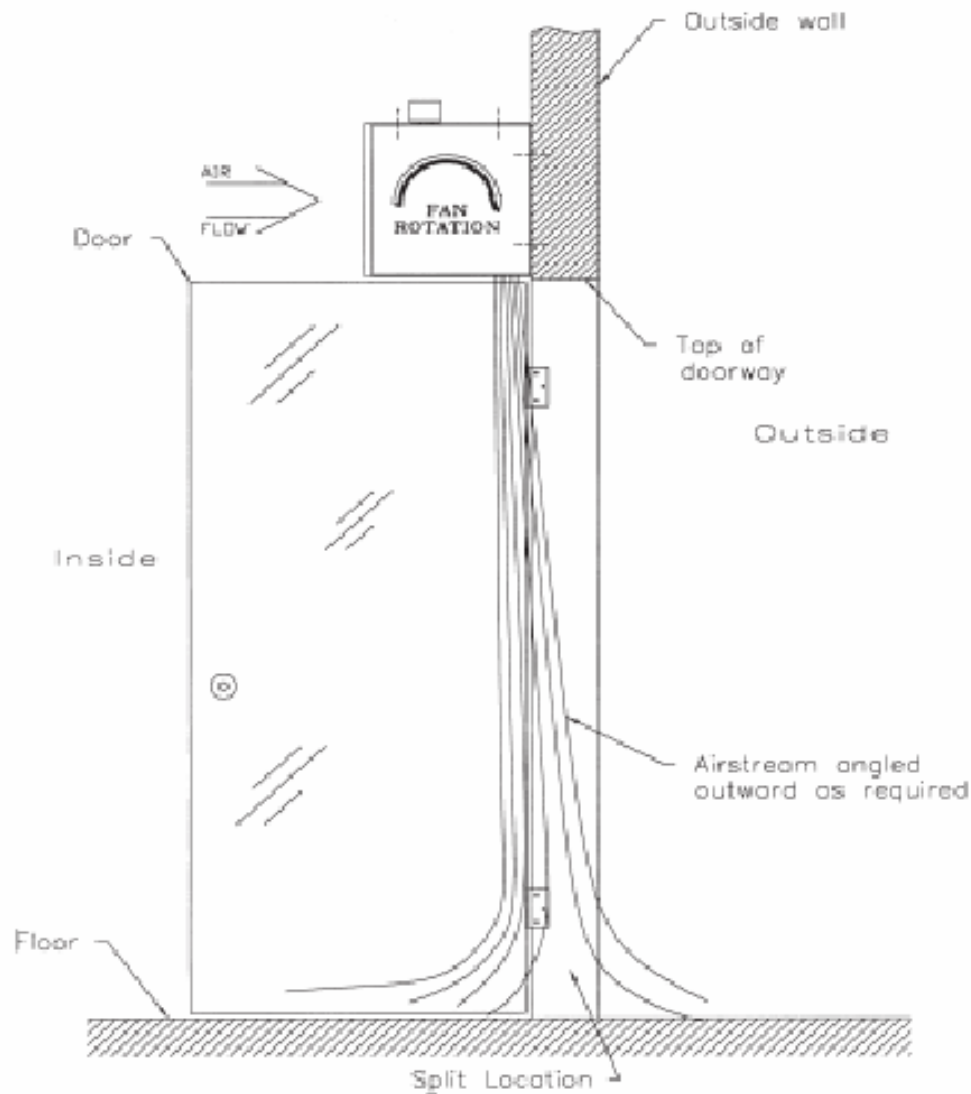
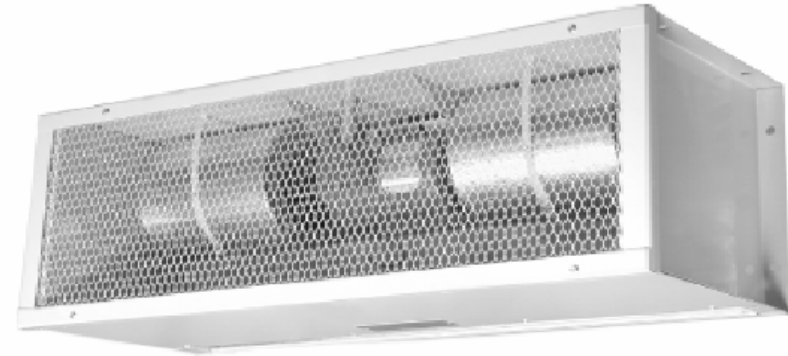
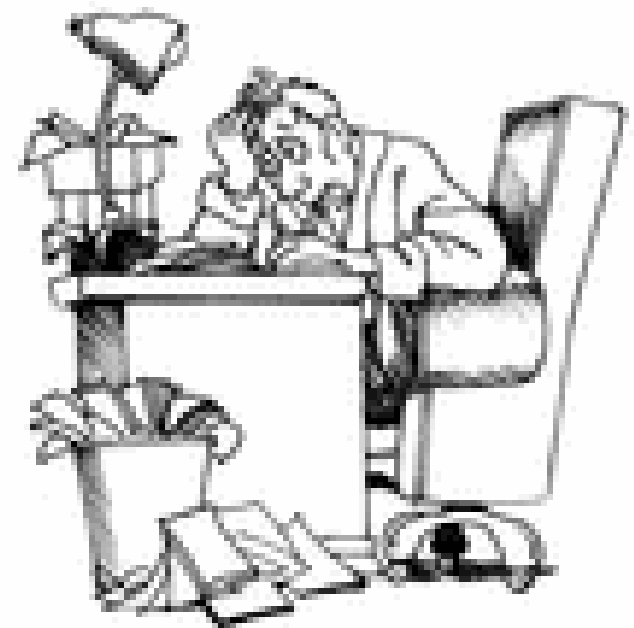
Air Curtain

Two AHUs for North Wing run in winter time even at night for freezing protection

Recommendations:

- ❑ 100% RECIRCULATION
- ❑ CIRCULATION PUMP

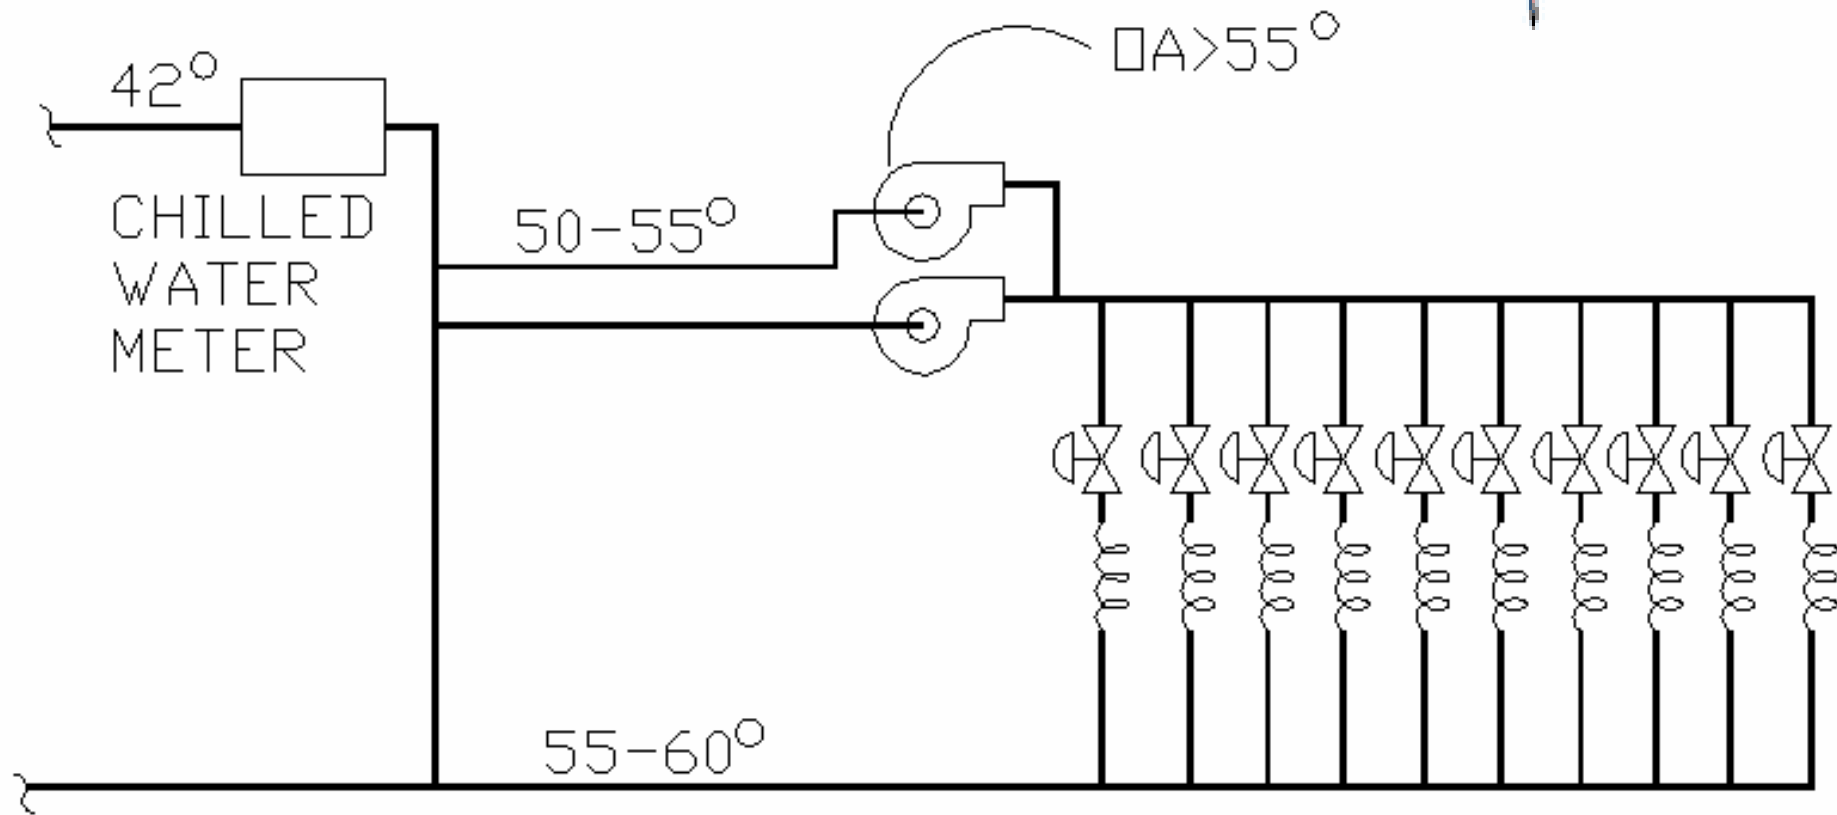
Chilled Water

Constant Flow

2-way Valve

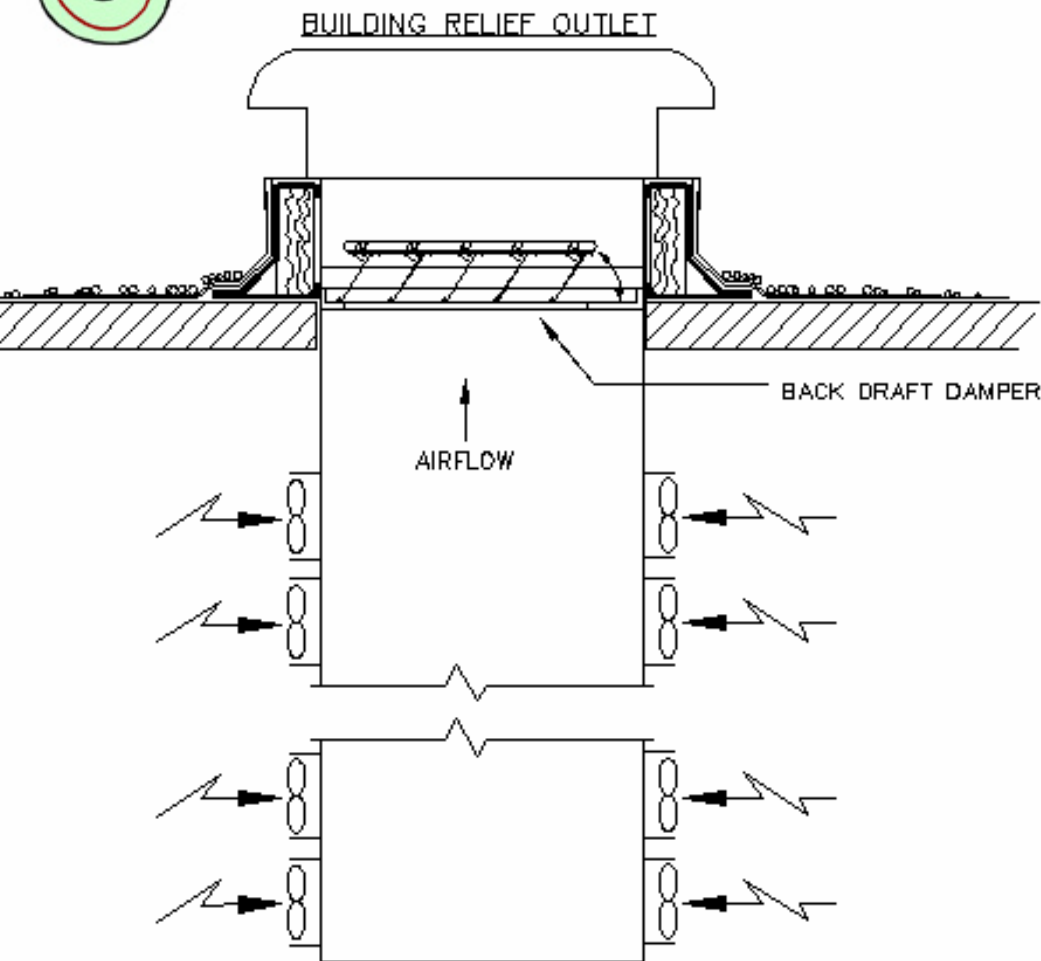
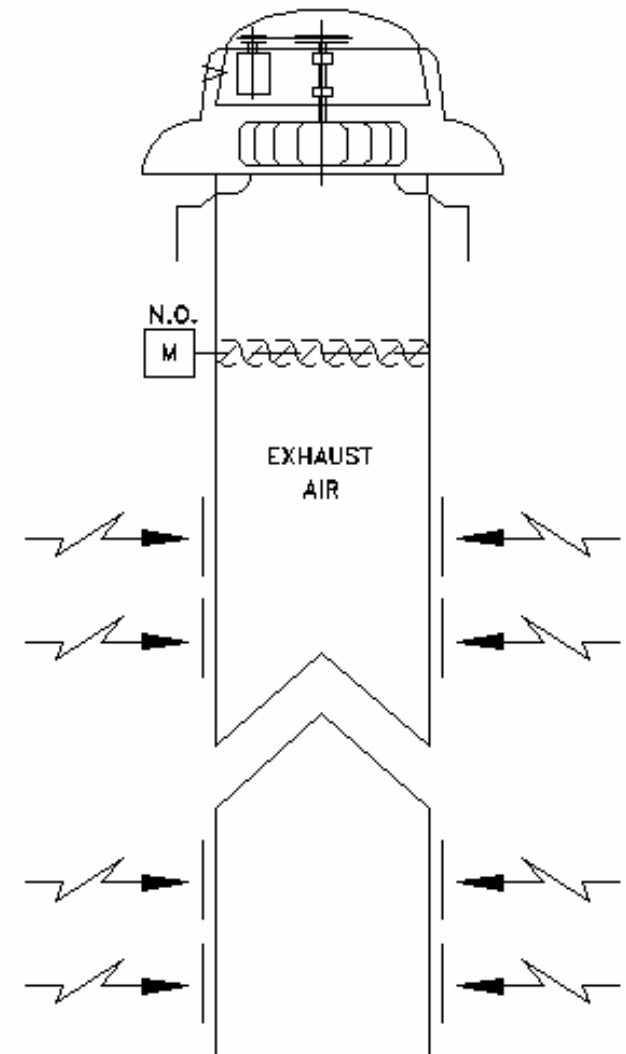
16 Rest Rooms In One Common Exhaust

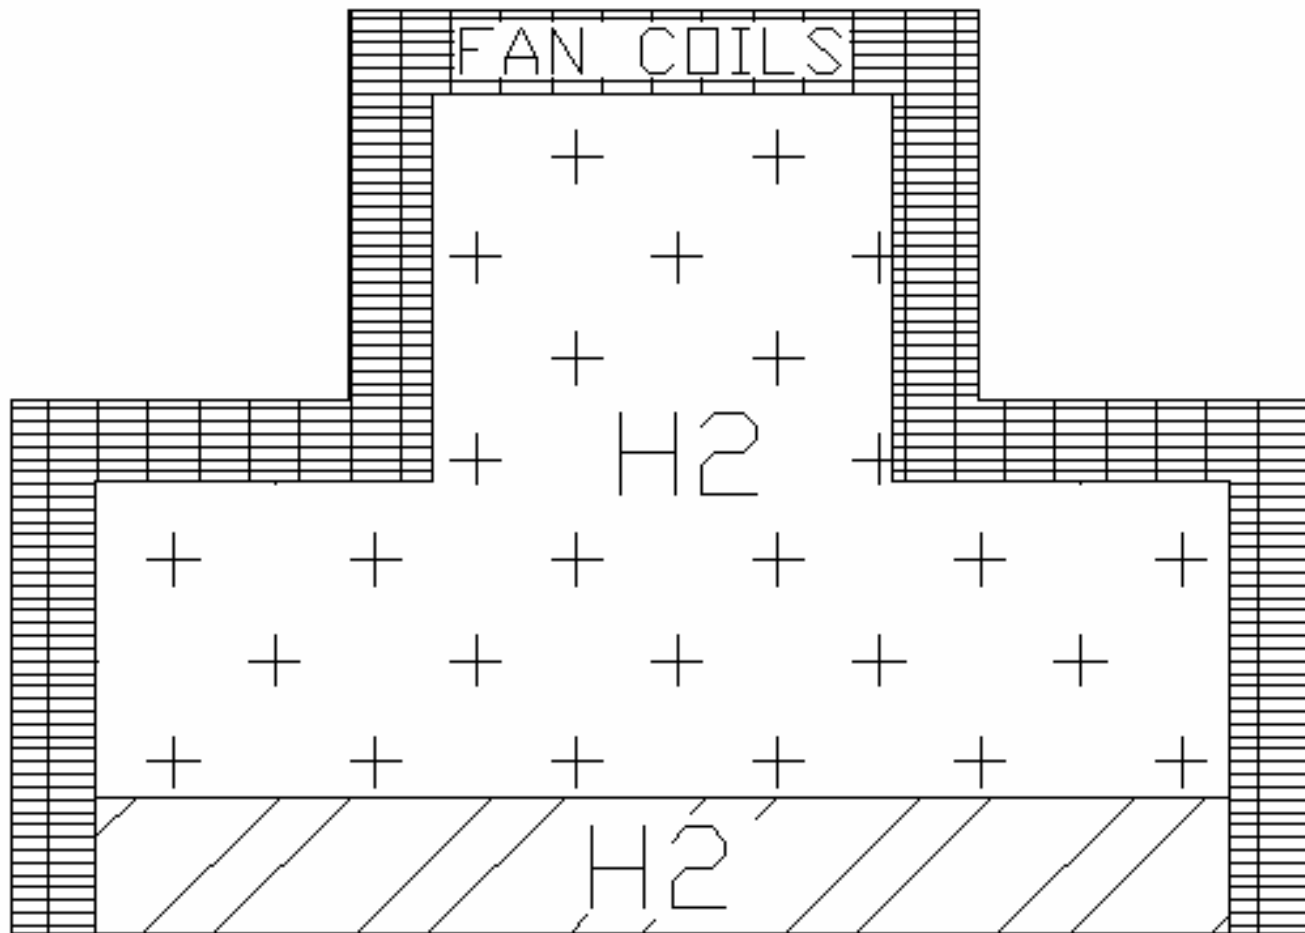
- ❑ Balancing problems on the 4th floor
- ❑ Return is not balanced
- ❑ Ductwork is not cleaned
- ❑ Some areas are overheated even in winter time

Recommendations

- ❑ Provide Units Control
- ❑ VAV system

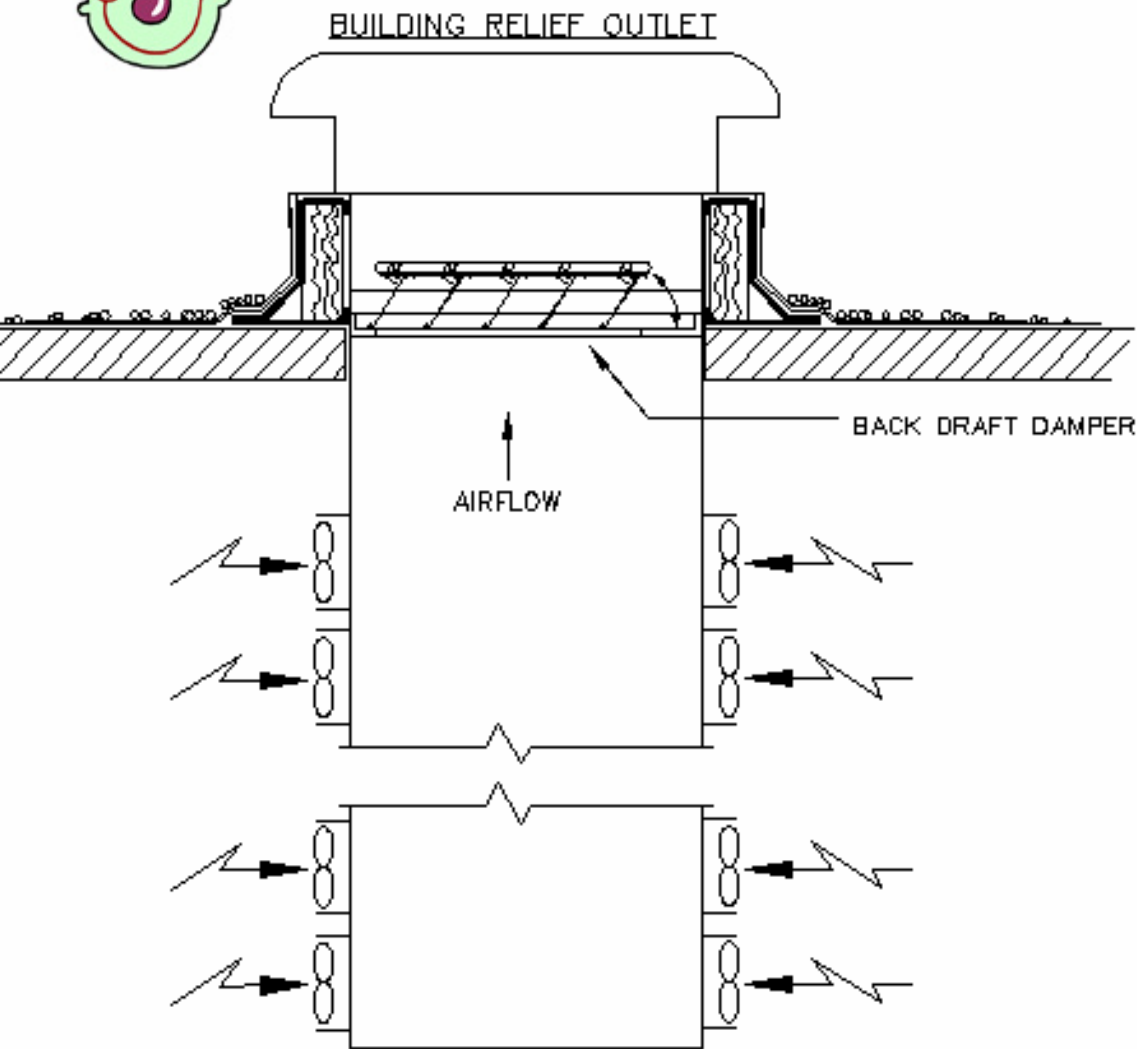
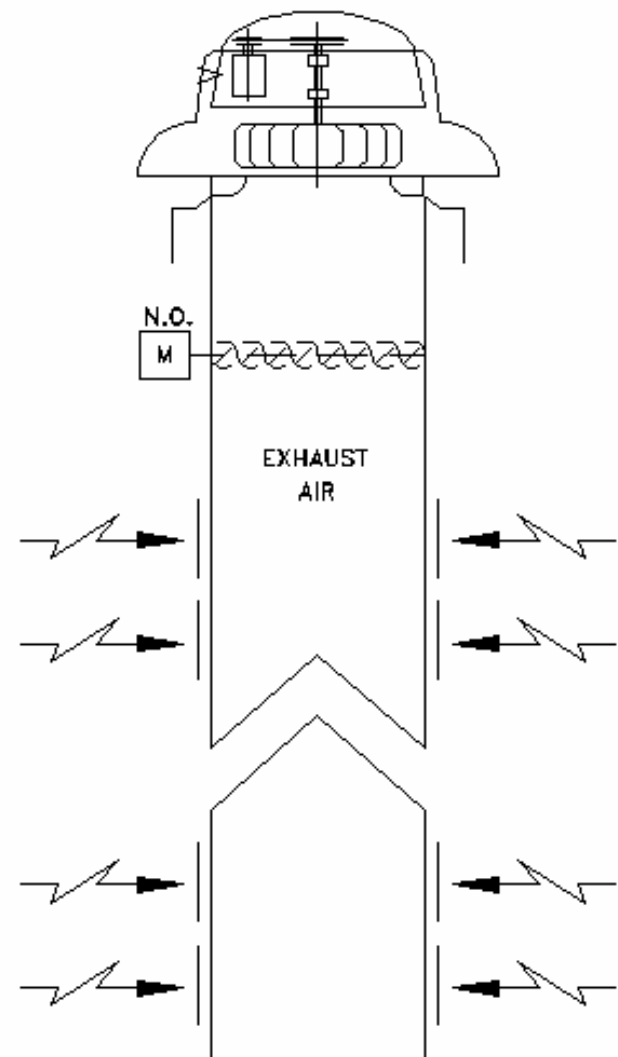
20 REST ROOMS IN ONE COMMON EXHAUST
